CALIBRATION CERTIFICATE

FAILURE EXPLANATION FOR

AEROTRAK® PARTICLE COUNTERS

APPLICATION NOTE CC-119 (A4)

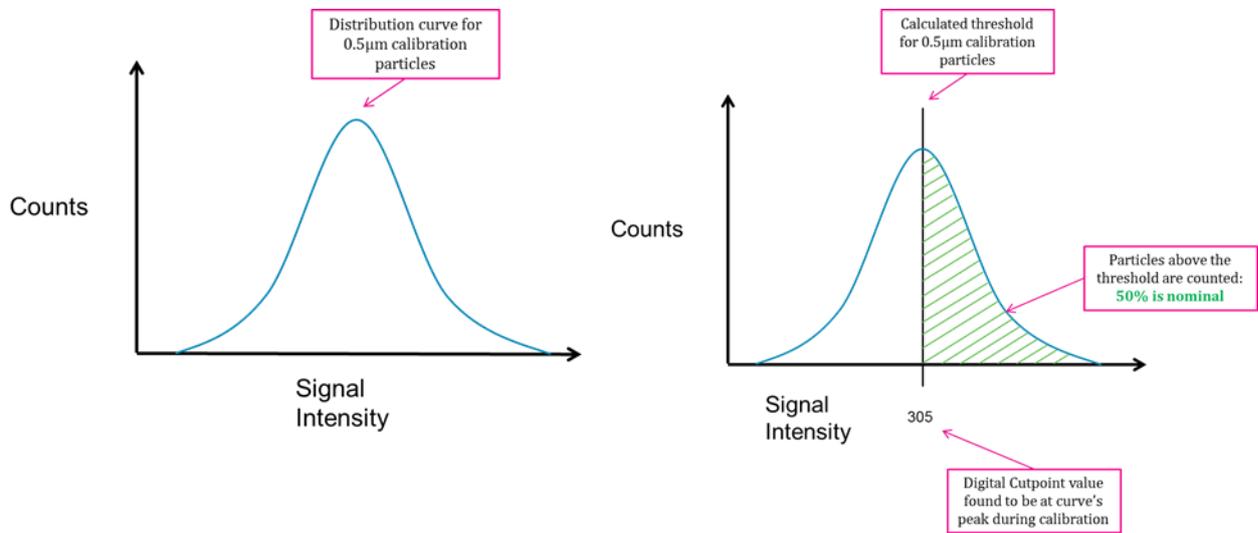
Figure 1

This section of the Certificate shows the current sizing capabilities of the particle counter as compared to the last time it was calibrated. The Digital Cutpoint is a value associated with a given size of a particle. When polystyrene latex (PSL) particles of a known size are measured during calibration, the intensity of the signal interpreted by the optics is then associated with that size of particle (see Figure 1). During the As Found Calibration, PSL particles of a known size are again measured to see if the value previously found still matches. The difference between the Digital Cutpoints is the Size Error. There are two possible failure modes for this section.

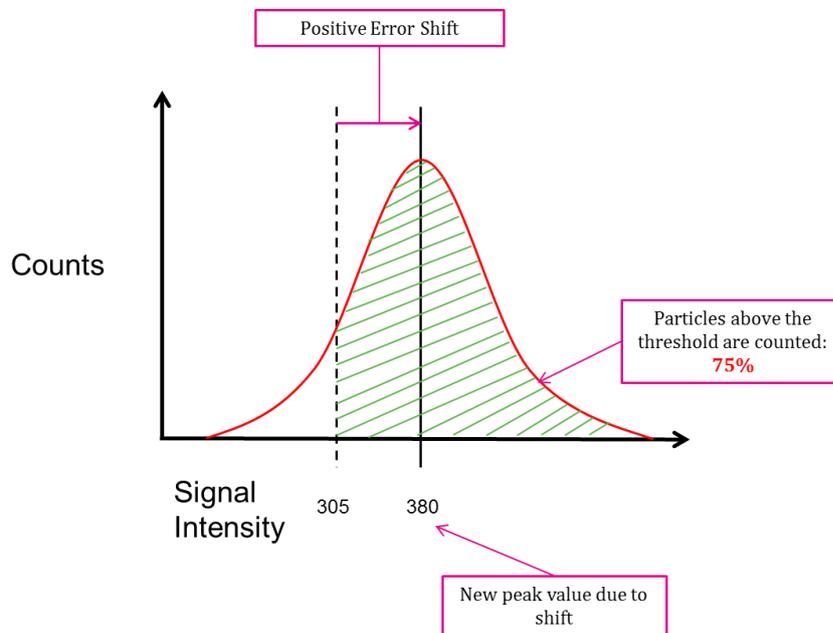
Figure 2

If the Size Error fails on the positive side, it means that the Digital Cutpoint has risen since the last calibration (see Figure 2). One possible reason for this failure may be that the airflow through the system is too slow. Particles passing through spend more time in the laser beam, causing more light to scatter and a higher intensity signal to be interpreted. This failure's impact is that some particles measured will be interpreted as larger than they actually are.

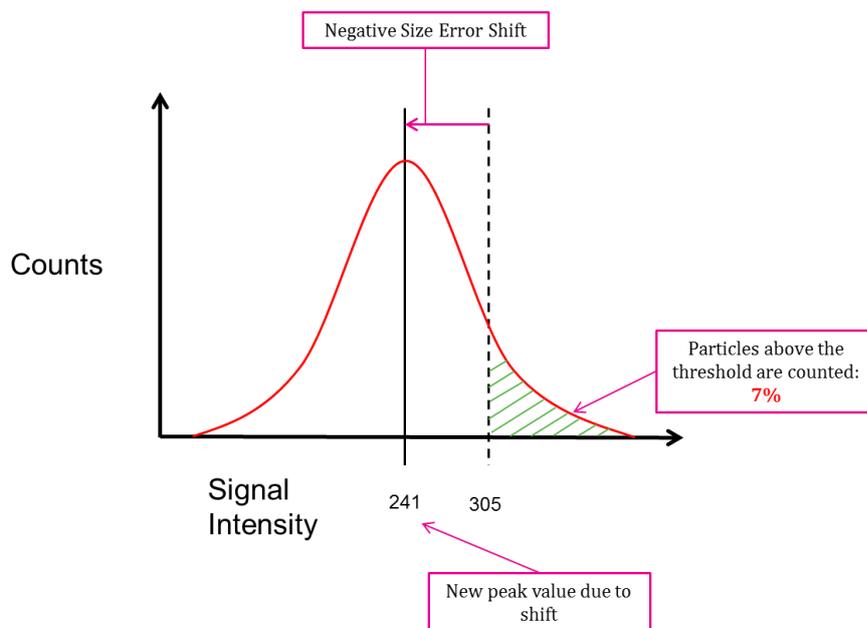
Figure 3

If the Size Error fails on the negative side, it is because the Digital Cutpoint has fallen since the last calibration (See Figure 3). Common reasons for this failure are contaminated optics (some scattered light is lost), laser misalignment or laser power drop (not enough light hitting the particles), or airflow is too fast (particles do not spend enough time in the laser beam). This type of failure may mean that the lower end of the channel was undercounted, and the higher end of the channel was over counted.

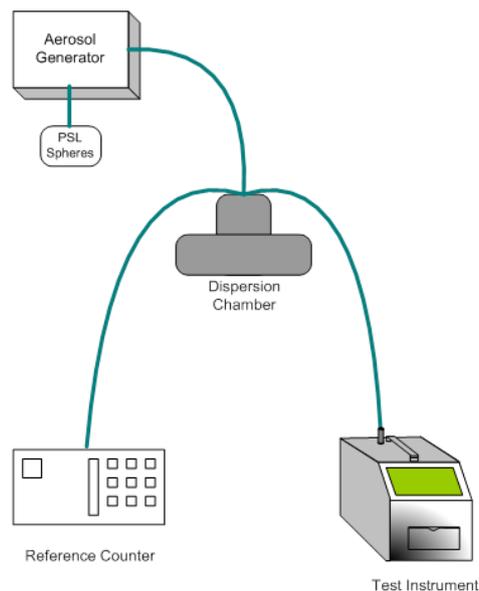
Figure 4

Counting Efficiency is tested to ensure that the particle counter is accurately counting the number of particles that pass through it. The particle counter under test is compared to a reference instrument (see Figure 4).

Counting Efficiency is tested at two particle sizes. The first size must be close to the minimum detectable particle size, and the second size is to be 1.5 to 2 times larger than the minimum detectable particle size. ISO 21501-4 requires that the counting efficiency near the minimum detectable size be 50 \pm 20%, and the larger particle size be 100 \pm 10% (the 50% requirement will be explained later in this application note).

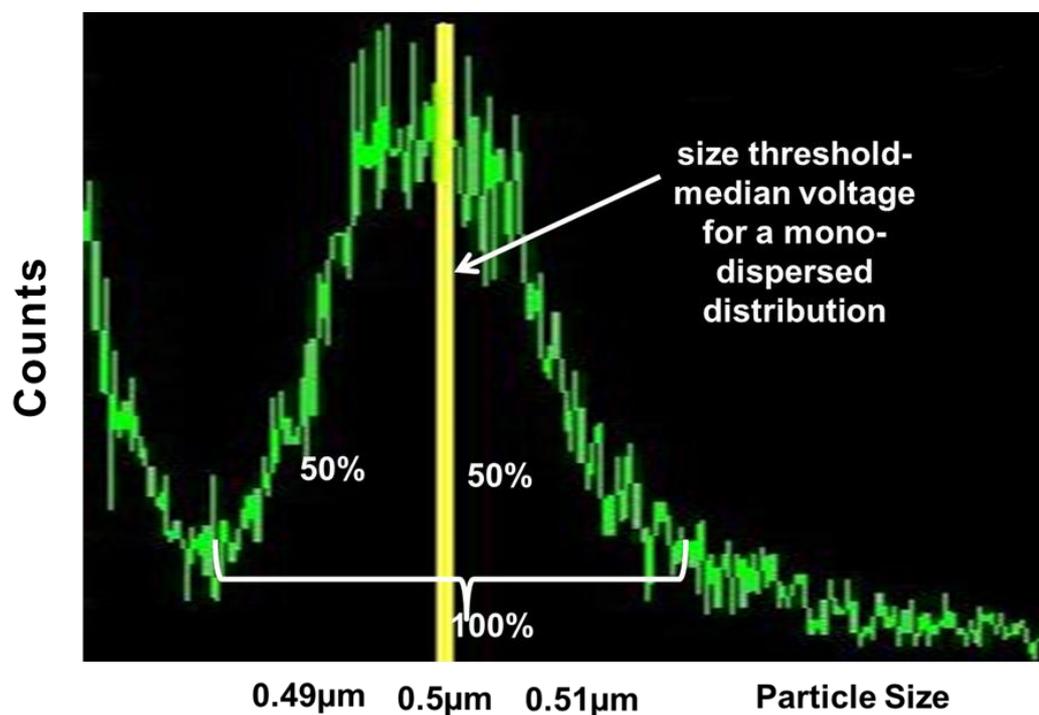
Figure 5

When a particle counter is calibrated, it uses Polystyrene Latex (PSL) particles of a known size with a known standard deviation from that size. Even though these particles are created in a lab to NIST traceable standards, nothing is perfect. If 0.5 μm PSL particles are used during calibration, some of them will invariably be smaller than 0.5 μm and some will be larger than 0.5 μm. When these PSL particles are introduced to the particle counter, they are sized and counted. The larger the particle, the higher the voltage of the signal interpreted by the instrument. Since the standard deviation of the PSL particle size is known, the median of the histogram is taken to be the threshold for the size of particle being measured (Figure 5), in accordance with ISO 21501-4. The 50% of counts above that threshold are larger than 0.5 μm and the 50% of counts below the threshold are smaller than 0.5 μm.

This is why a 0.5 μm channel counting 50% of the 0.5 μm calibration PSL particles is nominal. The other 50% of the PSL calibration particles are smaller than 0.5 μm and should not be counted as 0.5 μm particles. When using an instrument with a 0.3 μm channel and a 0.5 μm channel, 50% of the calibration PSL particles will still be counted in the 0.5 μm channel, the remainder will be counted in the 0.3 μm channel because they are actually smaller than 0.5 μm and therefore not large enough to be counted in the 0.5 μm channel.
