# Investigation Reveals Faulty Exhaust Fan

P-TRAK™ Ultrafine Particle Counter Case Study #2

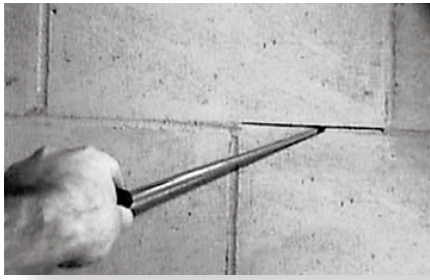
### UFPs Tracked to the Source...

• Background (outdoors)	11,800
• Supply air and surrounding areas	850
• Poison center	13,200
• Above ceiling tile in poison center	29,700
• At wall abutting ambulance bay	162,000
• Poison center after exhaust fan repair	850

itself. By checking wall and ceiling penetrations, the investigator quickly identified the source pathway. Elevated UFP levels were entering the poison center through the ceiling tiles. Further investigation showed UFP readings above the ceiling tiles as high as 29,700. Using the P-TRAK™ Ultrafine Particle Counter, the investigator tracked increasingly higher UFP levels to joints in the concrete wall blocks, where measurements exceeded 162,000. On the other side of the wall, the investigator found an ambulance bay and learned that an ambulance had just left the area.

The high UFP levels at the wall, in combination with those in the adjoining ambulance bay, prompted building management to check the ambulance bay exhaust system. Management quickly determined that the starter motor for an exhaust fan was malfunctioning.

After maintenance repaired the exhaust fan starter and sealed the block joints in the wall, a follow-up survey using the P-TRAK™ Ultrafine Particle Counter showed UFP levels in the poison center equal to those in supply air and adjacent offices. Complaints from the poison center staff ended.

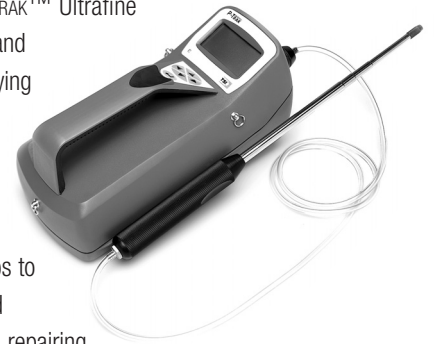
The P-TRAK™ Ultrafine Particle Counter uses fundamental measurement technology proven around the world in research and industrial applications since 1978. Its data logging feature allows the user to download field measurements for evaluation in TSI's TRAKPRO™ Data Analysis Software or in common word processing and spreadsheet programs, simplifying record keeping and reports.
